Re: USACE
Bridges at Lake Parc Residential Subdivision (20.9 acres)
47 Lakes Road, Village of Monroe, Orange County
16PR01672

STRUCTURAL INTEGRITY ASSESSMENT

45 Lakes Road
Monroe, New York

May 2023

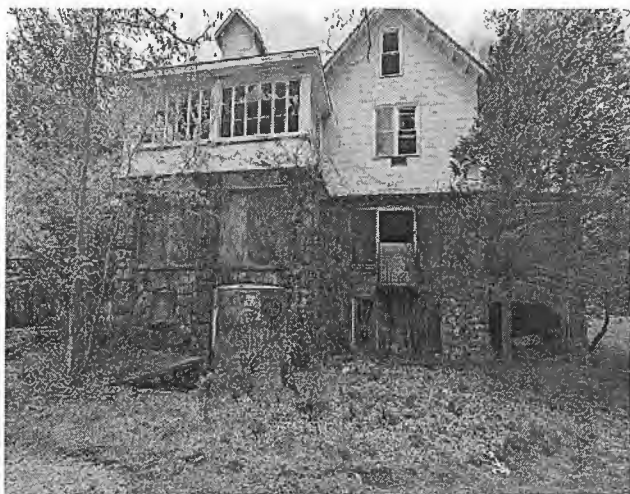
Side View

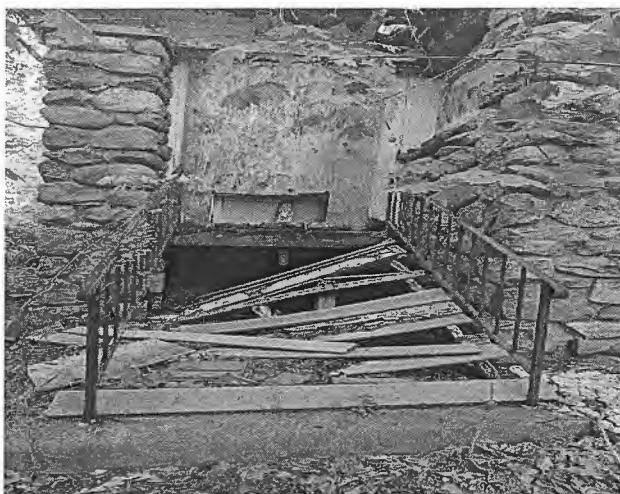
Foundation Settlement and Deterioration

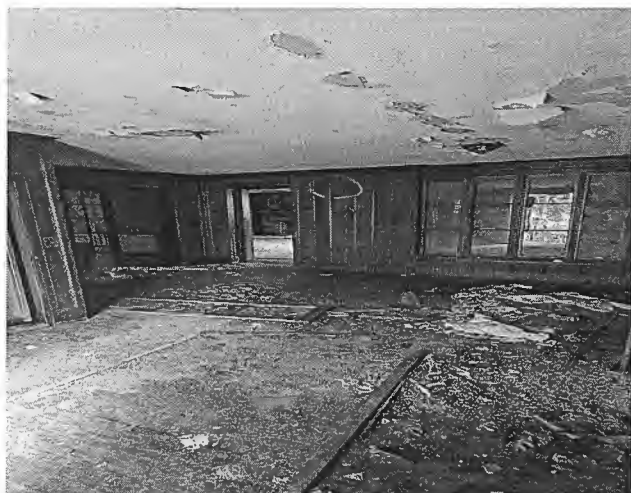
Floor & ceiling damaged by water intrusion

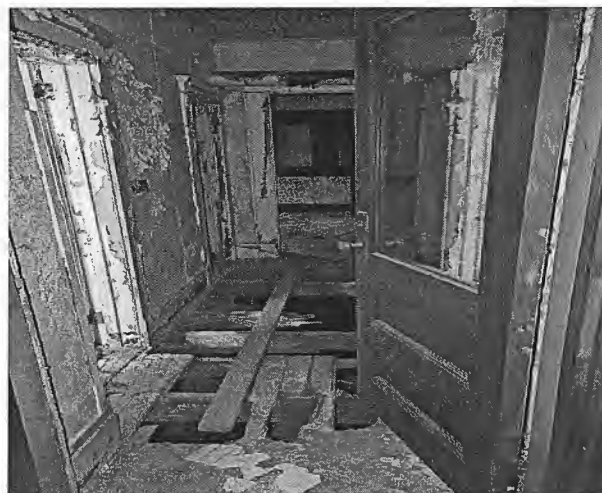
Severe floor damage

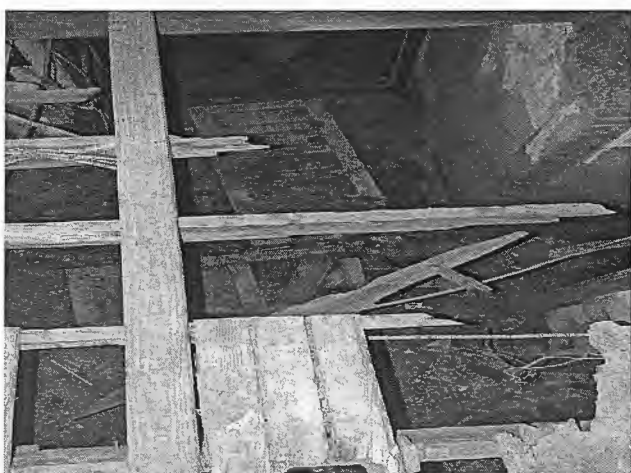
Severe floor damage

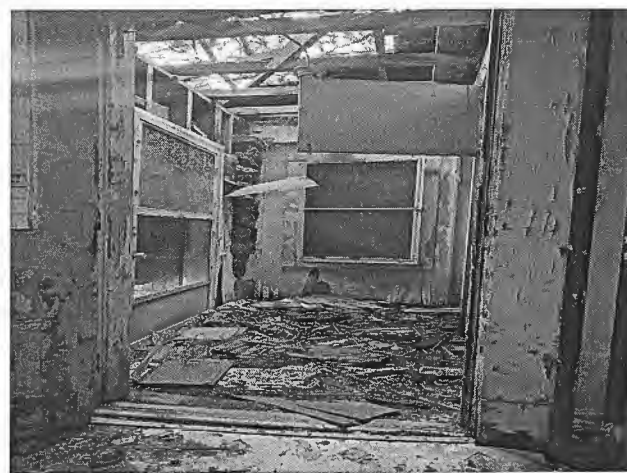
Roof collapse

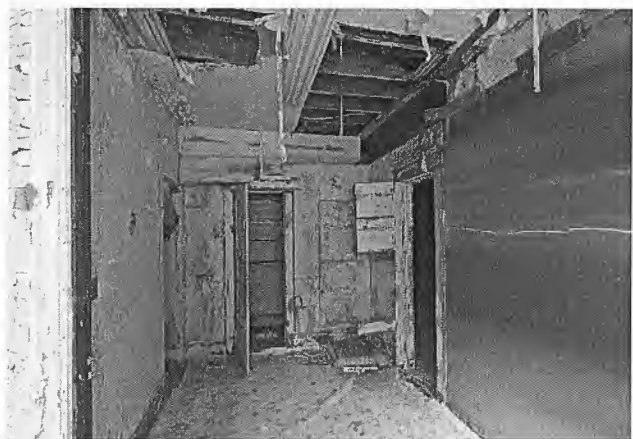
Celing collapse

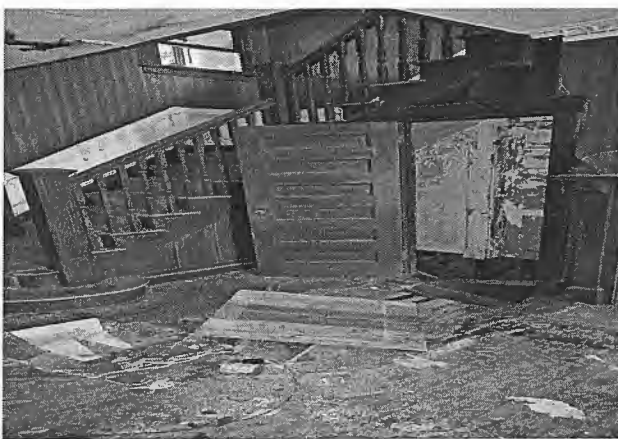
Floor collapse

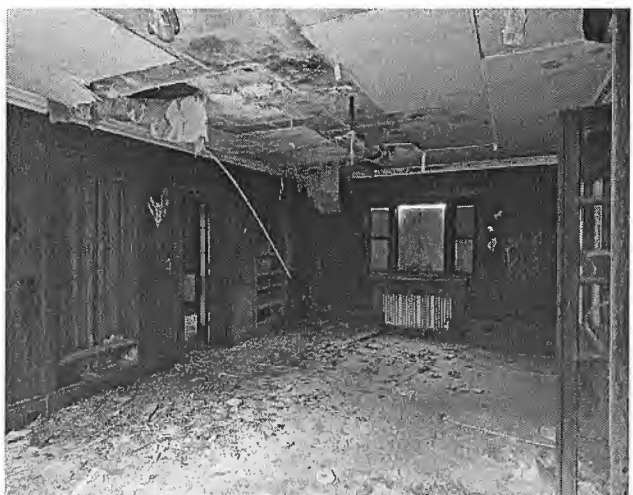
Mold and celing colapse

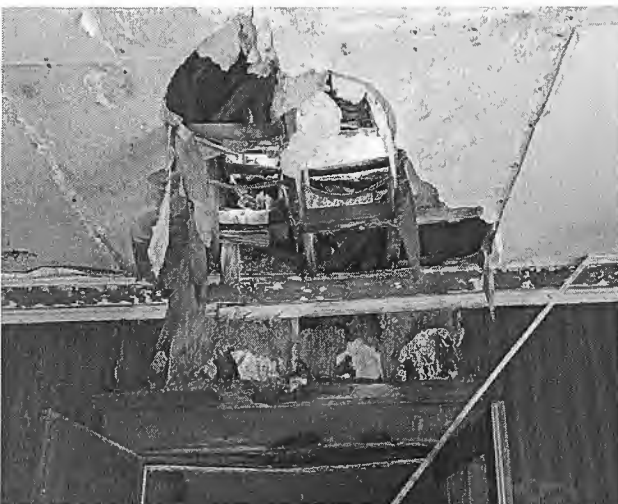
Mold and celing colapse

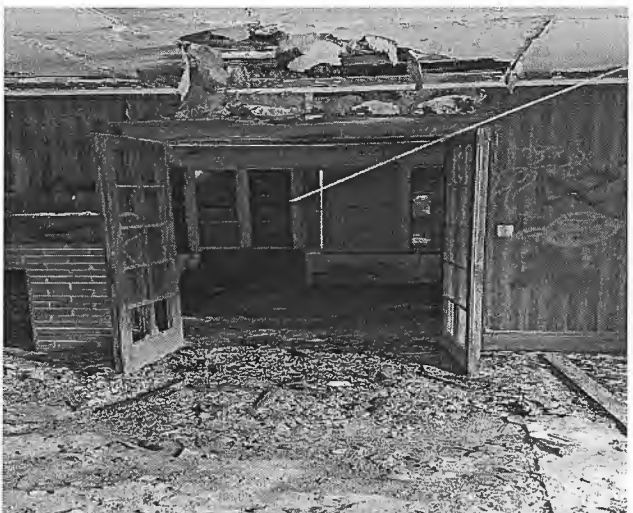
Mold & celing colapse

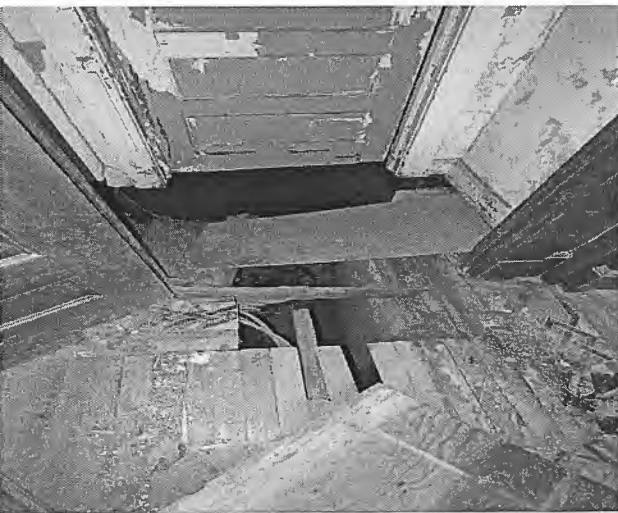
Floor collapse

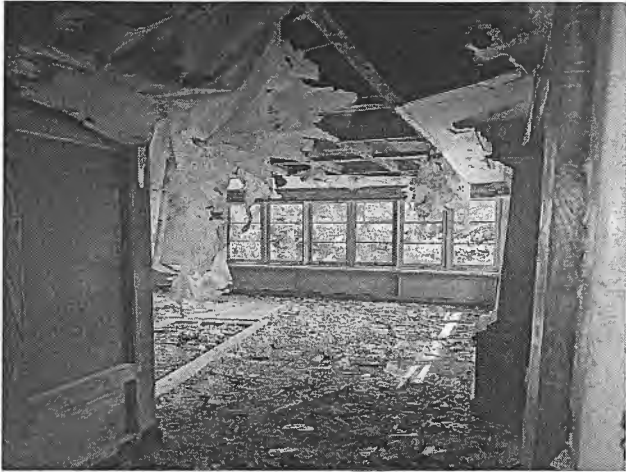
Ceiling collapse

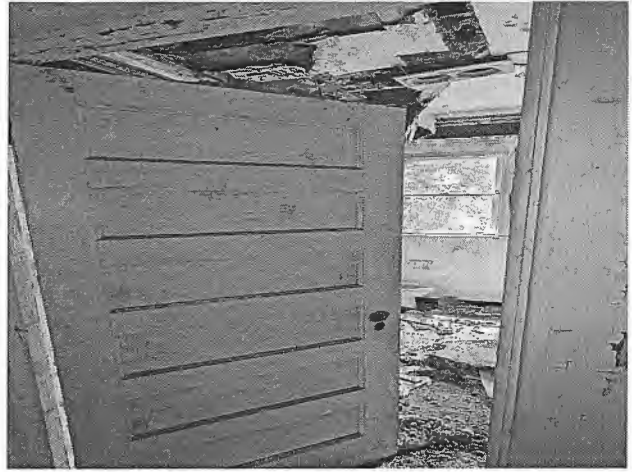
Ceiling collapse

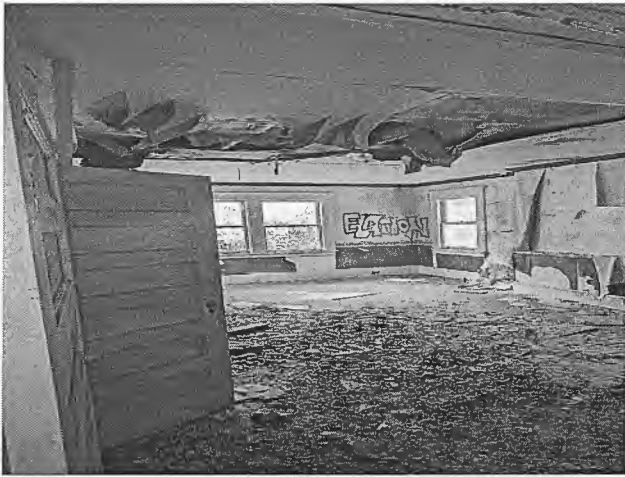
Ceiling collapse

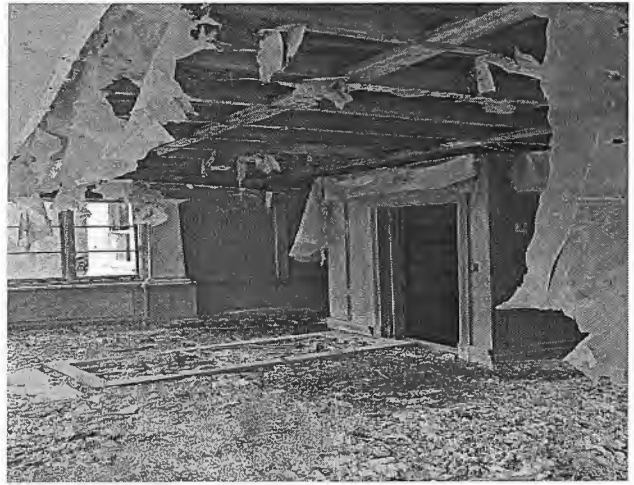
Ceiling collapse

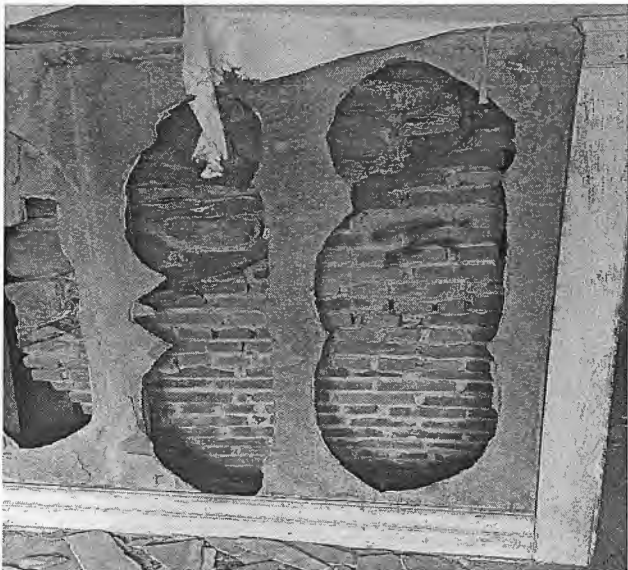
Deteriorated Fireplace

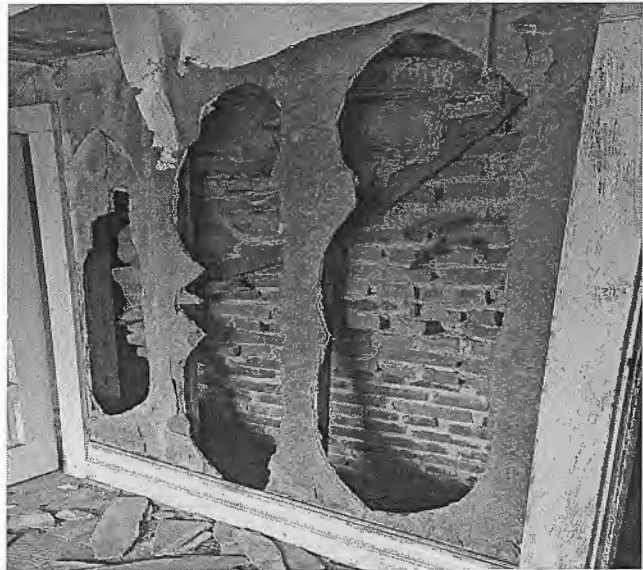
Deteriorated Fireplace
